**Pine Creek/Sulphurbeds Allotment:
Grassy Creek Spring**
Mary O'Brien
Grand Canyon Trust

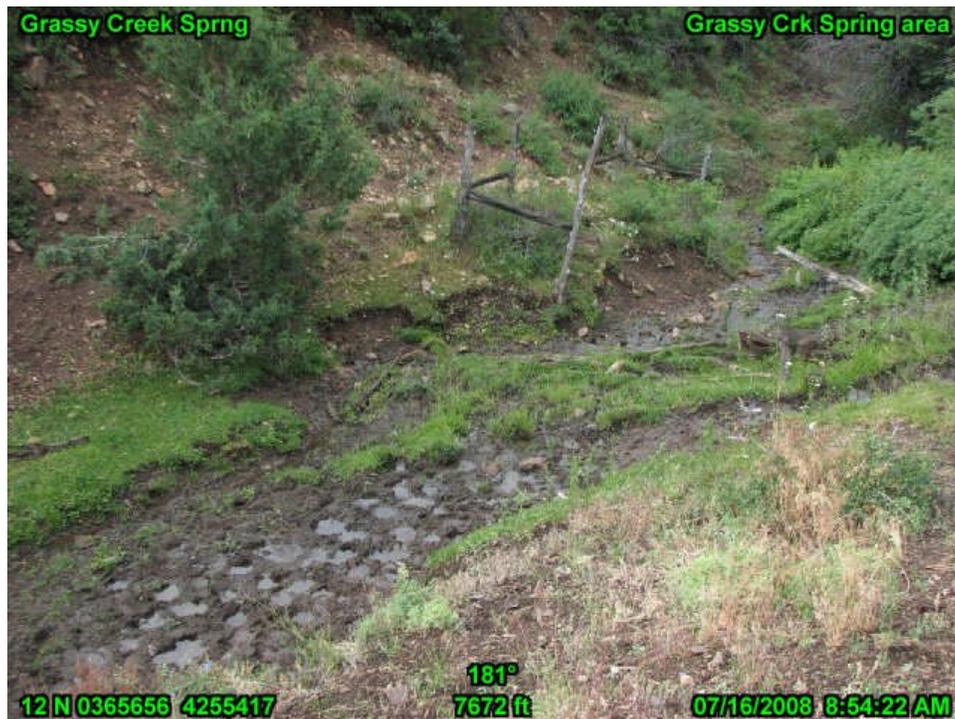
Grassy Creek Spring lies midway up Grassy Creek at the southern end of Pine Creek/Sulphurbeds Allotment. An old spring development has broken down, and cattle are directly trampling the creek and spring area (Fig. 1) and the wetlands below the spring (Fig. 2). Capacity on the heavily-grazed adjacent uplands is questionable, given the cover of cattle-avoided lupine and cheatgrass (Fig. 3).

Fig. 1 Pine Creek/Sulphurbeds: Trampled creek banks and wetlands; spring development in disrepair.

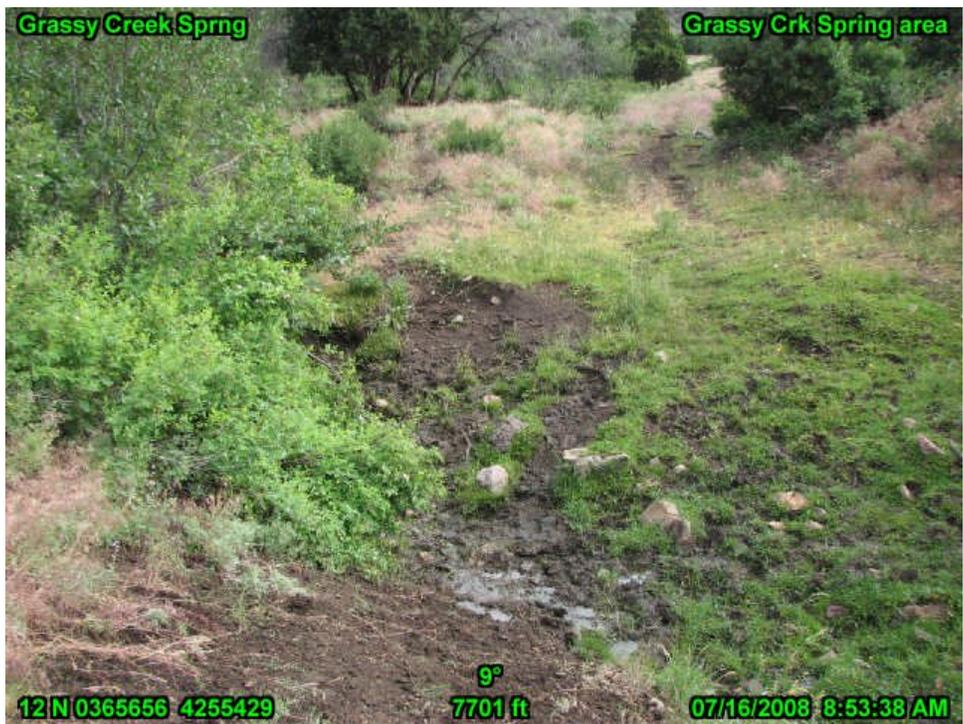
Fig. 2. PineCrk/Sulphurbeds: Trampled spring area and wetlands.

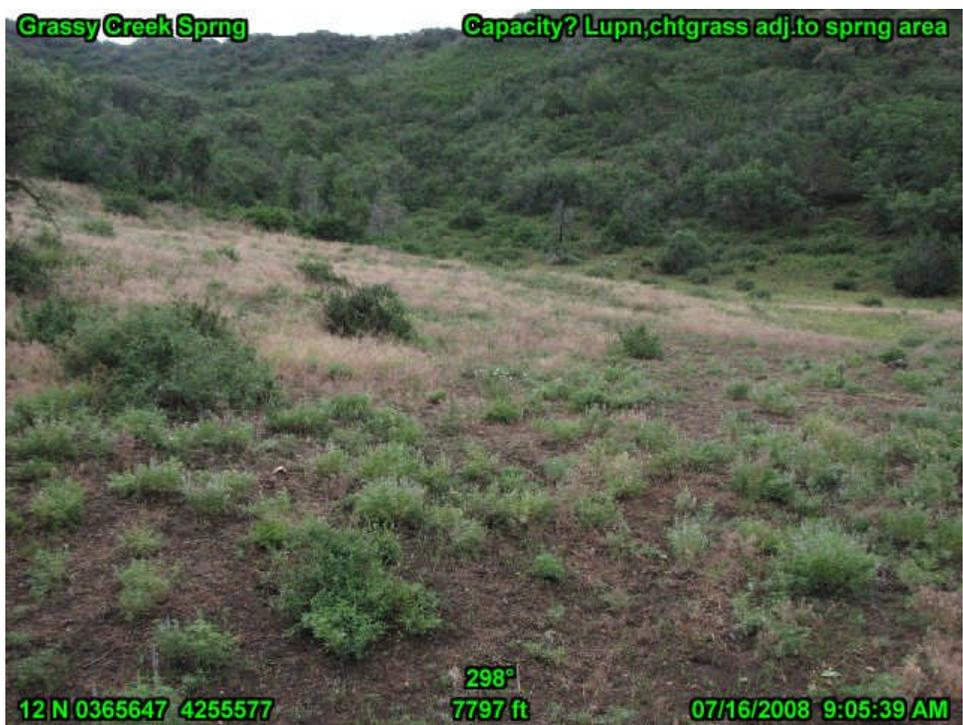
Fig. 3. Pine Crk/Sulphurbeds: Slope adjacent to spring area. Lupine and cheatgrass are dominants.

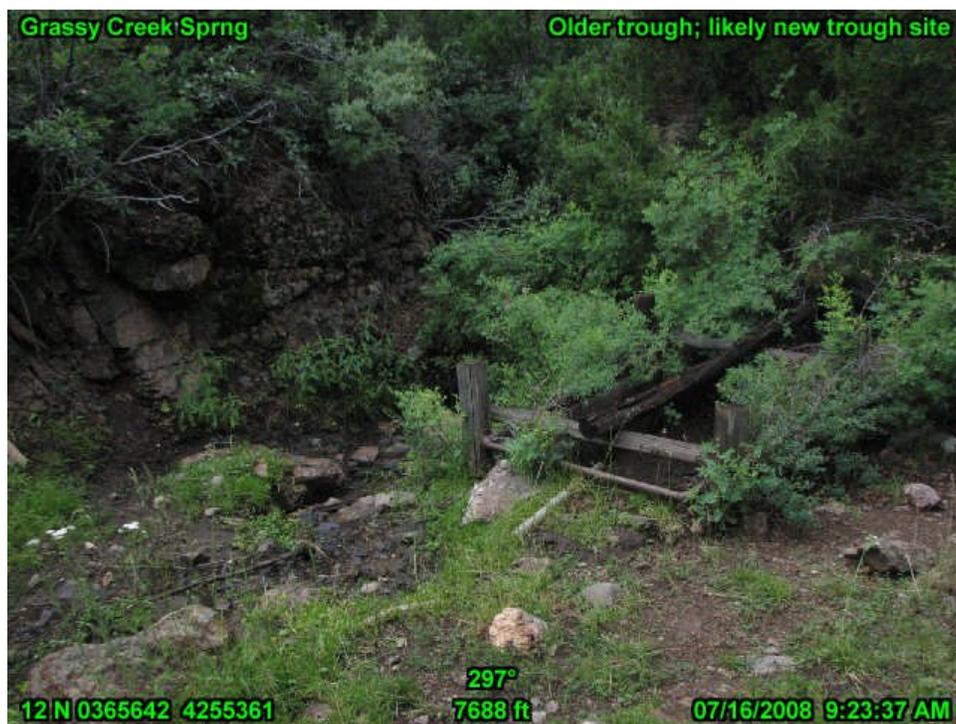
Fig. 4. Pine Crk/Sulphurbeds: Potential water trough with entrance from road

If this area were to be considered productive enough for cattle, a trough might be built near the older spring development, with an entrance from the road (Fig. 4). The cliff wall immediately behind would armor one side of the trough. Protection of the spring and its wetlands as well as the creek from trampling would remain a problem.
